Wallerawang Power Station – Ash Dam

Sawyers Swamp Creek Realignment Progressive Rehabilitation Plan - Stage 1

Prepared for Generator Property Management

E220618 RP7

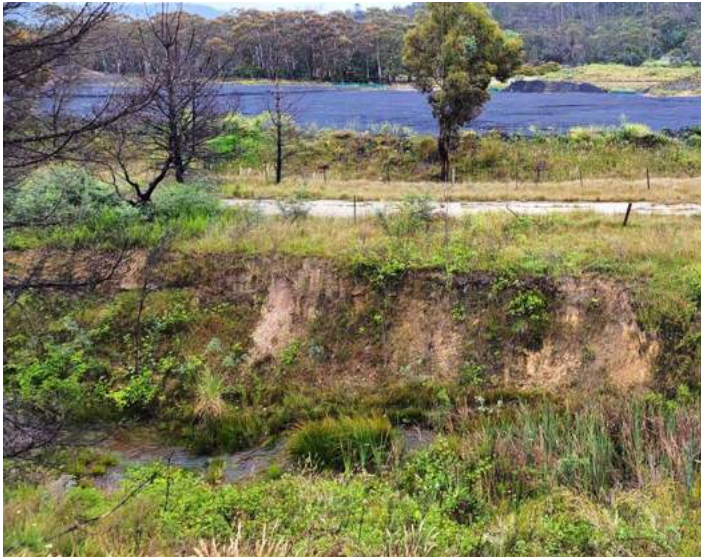
Sawyers Swamp Creek has a good coverage of instream vegetation however the channel banks are unstable throughout much of the watercourse section downstream of the spillway channel. Example areas of channel bank instabilities included adjacent to the existing KVAR embankment and Kerosene Vale stockpile area where the bank was exposed soil with a near vertical batter, suggesting erosion through capacity constraints; and the watercourse section adjacent to Lidsdale Cut where gully erosion is evident (refer to Figure 3.3).

Northern channel bank, adjacent to the KVAR and Kerosene Stockpile Area – in Stage 1 area

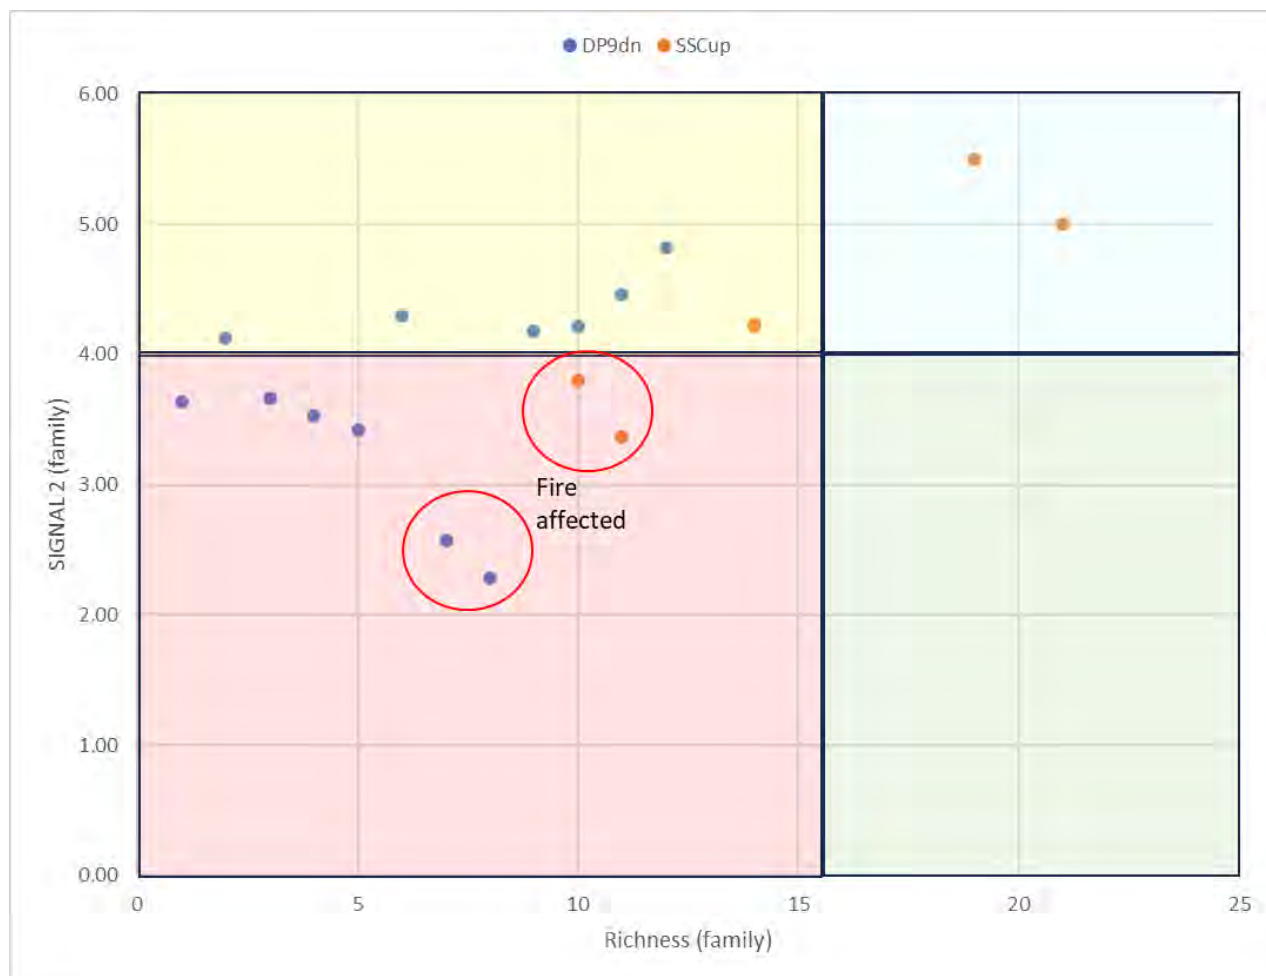
Pervious studies were under taken in 2006, their results summarised that SSC was degraded , with poor what quality and a relatively dapauverte faunal assemsbilage. Of the macroinvertebrate taxa present were of pollutant tolelrat species. However the survey only focused on the lower SSC and the Coxs River and refence sites.

Figure 2.4 Macrinvertebrate indices plotted from the Kerosene Vale property

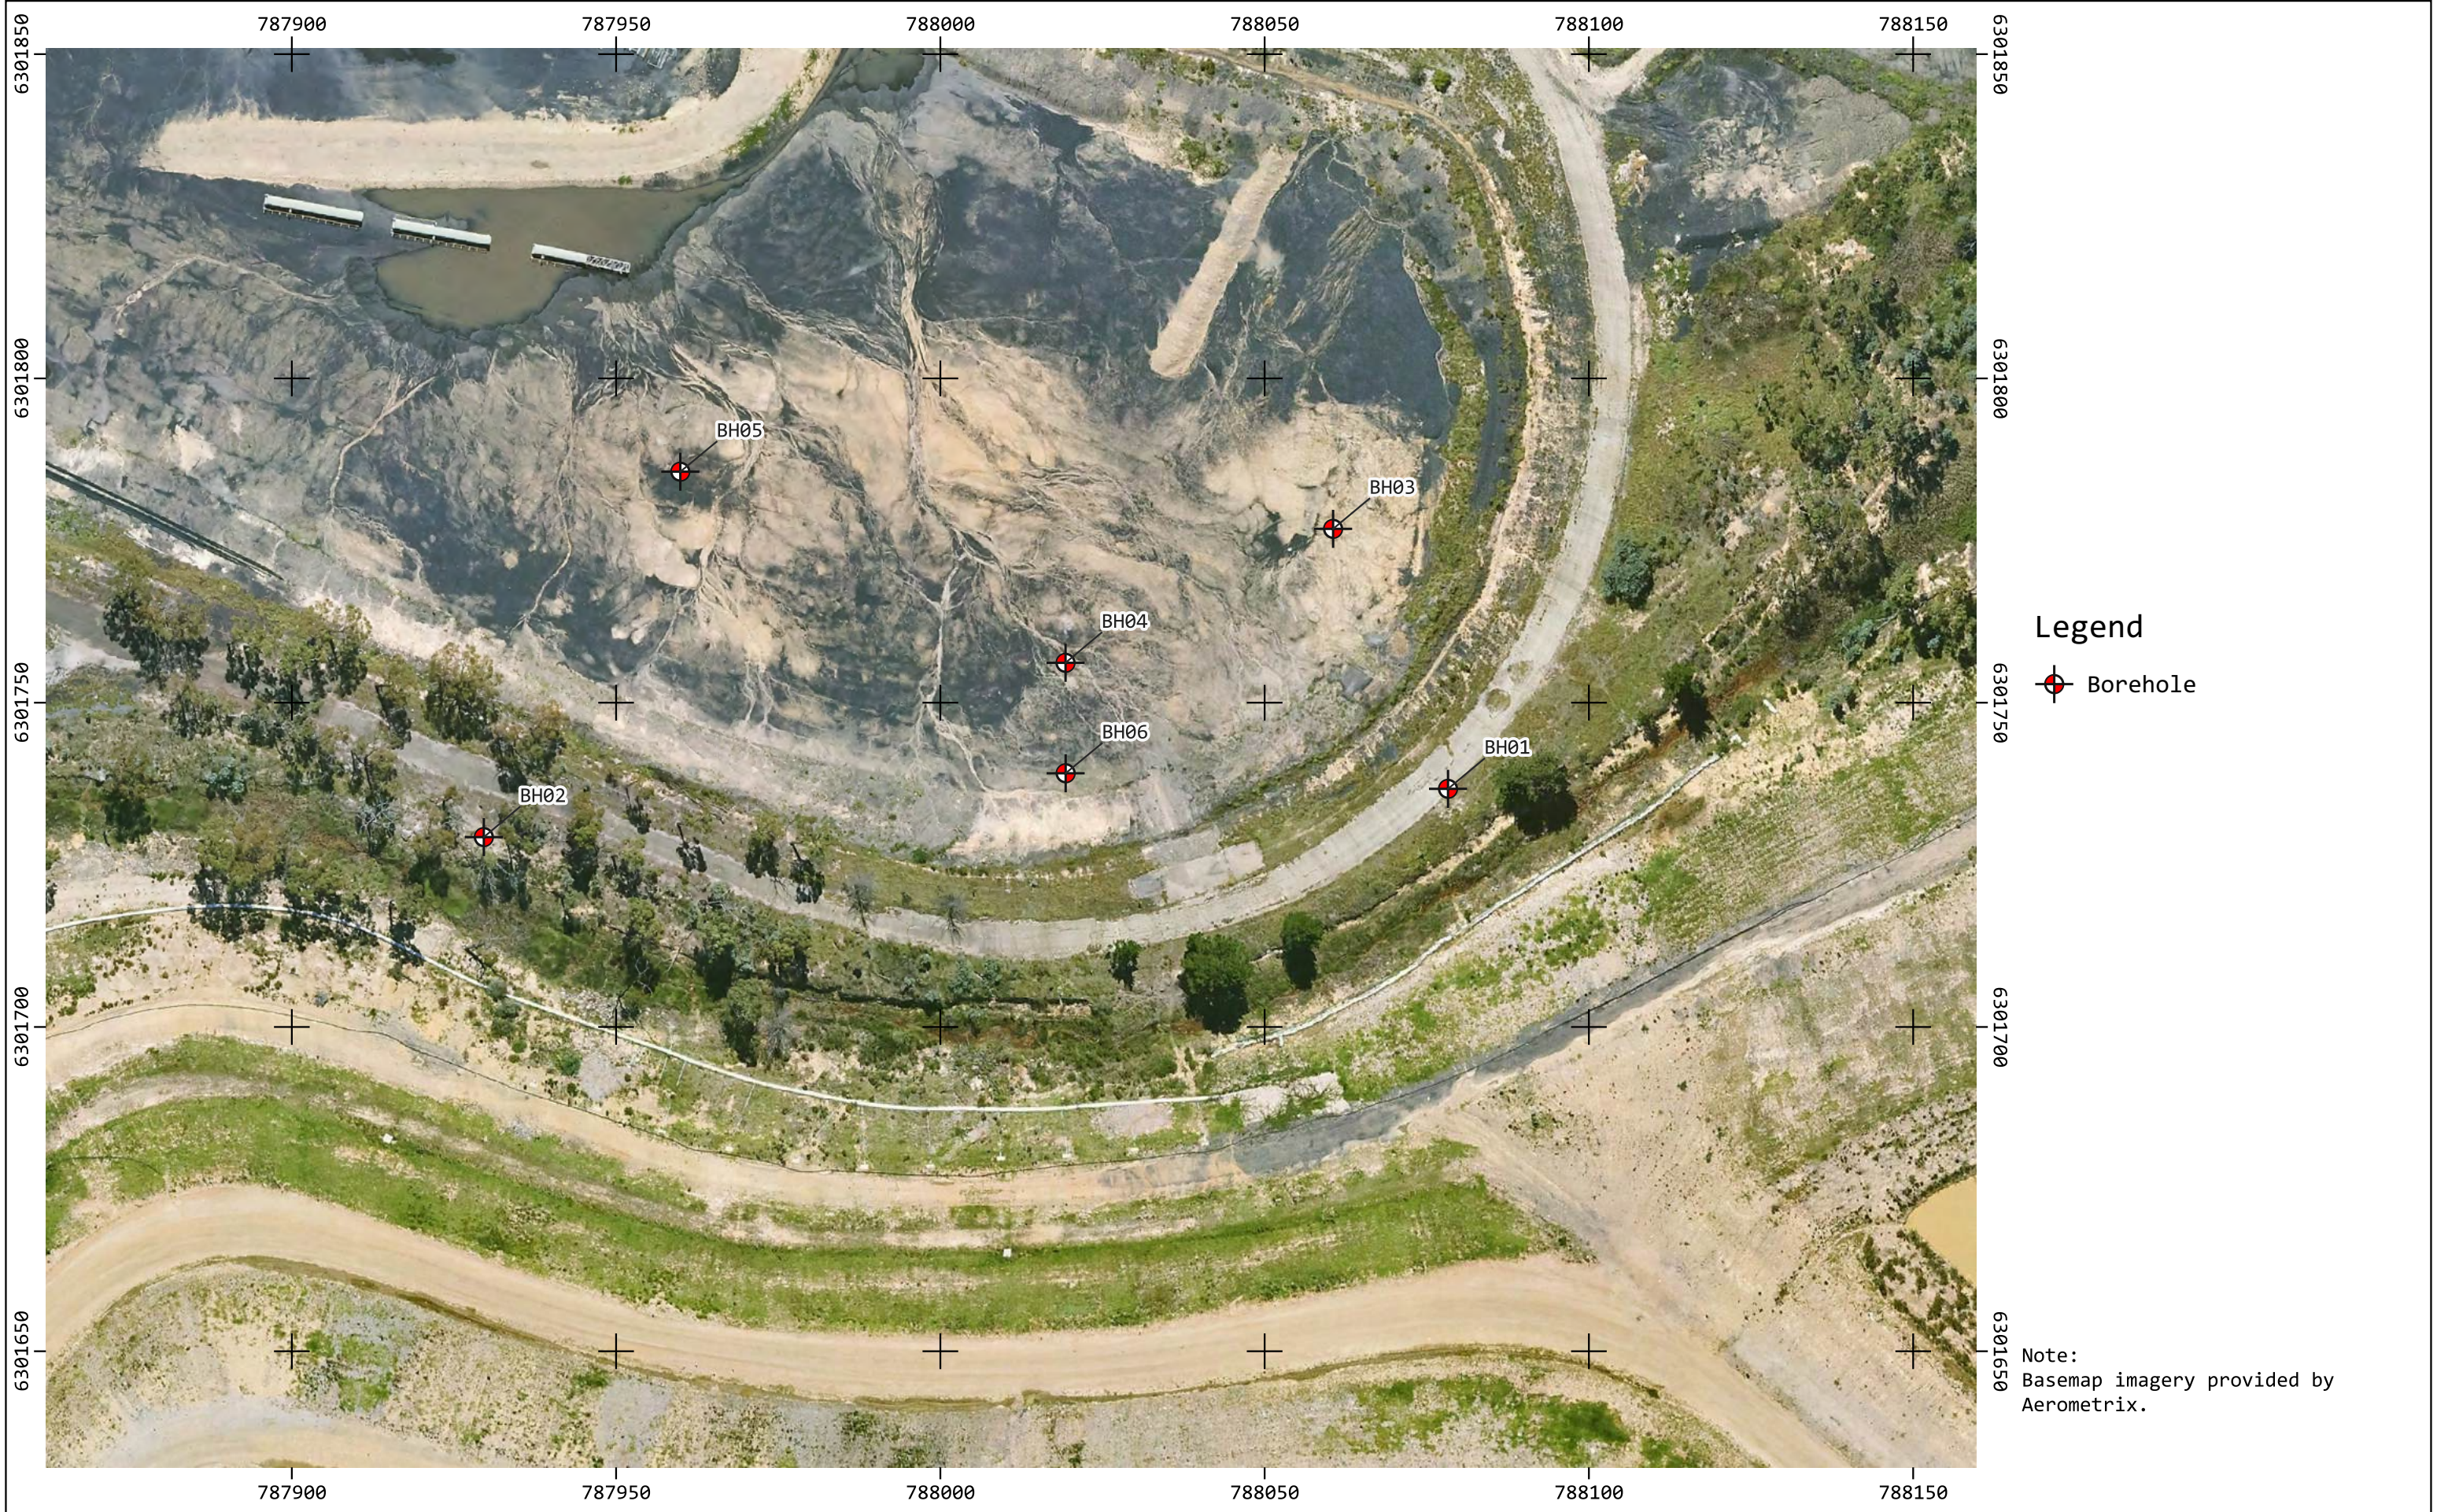
Client: GPM	Drawn: JH	<p style="text-align: center;">KVAR Creek Realignment Test Location Plan</p> <p style="text-align: center;">Scale - 1:917 at A3</p>		Project ID: G23994
	Project: KVAR Creek Realignment	Checked: MW			Drawing ID: G23994_TLP_01
	Location: Lisdale NSW	Date: 24-04-04			
Macquarie Geotechnical Pty Ltd 3 Watt Drive, Bathurst NSW 2795 - www.macgeo.com.au		CRS: GDA2020 / MGA zone 55 (EPSG:7855)
